A Case Study in Forensic Meteorology: Investigating the 3 April 1956 Tornadoes in Western Lower Michigan

ERNEST J. OSTUNO

NOAA/National Weather Service Forecast Office, Grand Rapids, Michigan

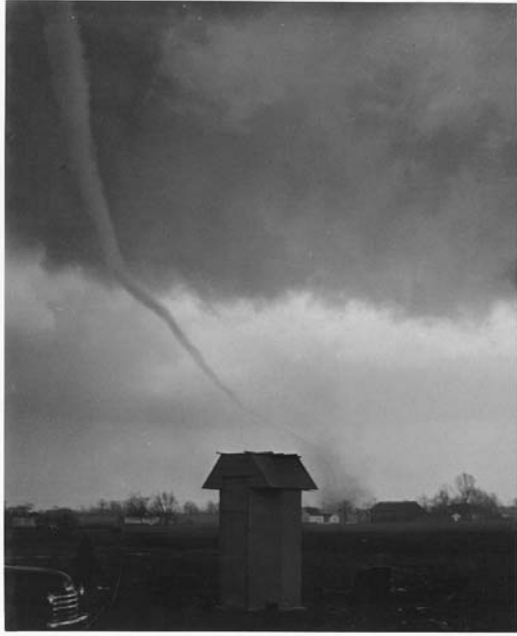
Figure 2: The Saugatuck to Holland tornado is seen here in its eighth mile on the ground. The damage path would end after one more mile. Photo credit: Jarvin Kleiman.

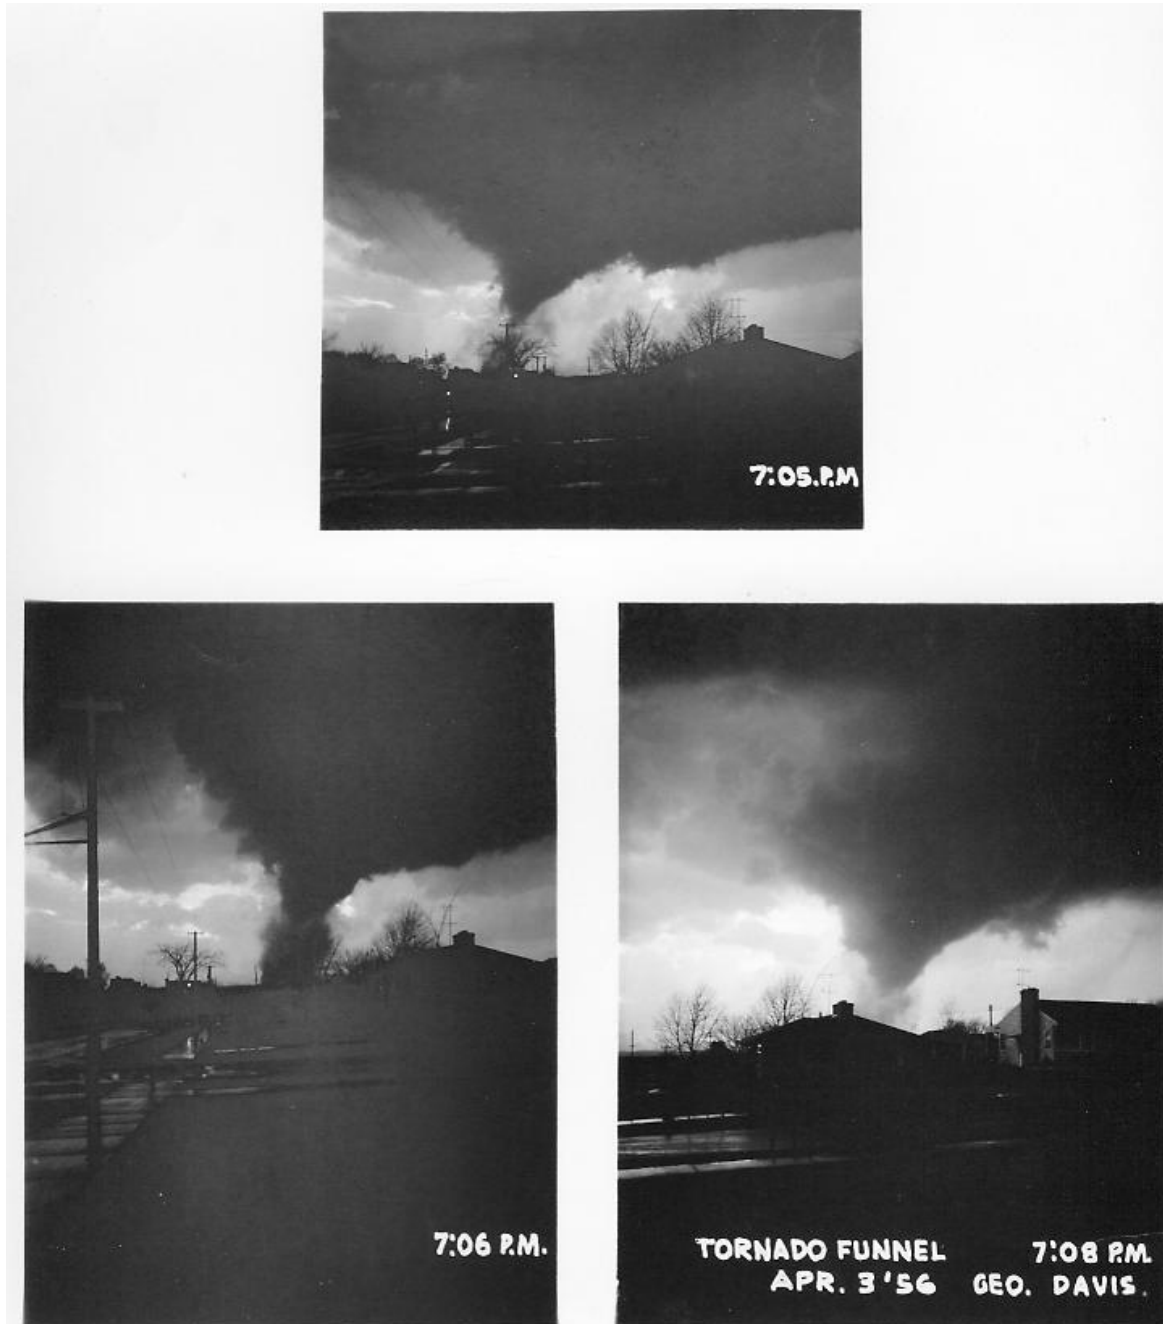
Figure 3: The Hudsonville to Lakeview tornado moving through Standale. Photo credit: George Davis.

A series of photos of the Hudsonville to Lakeview tornado at Standale were labeled with the times that they were taken (Fig. 3). This was useful in corroborating other eyewitnesses' accounts of the storm's timing.

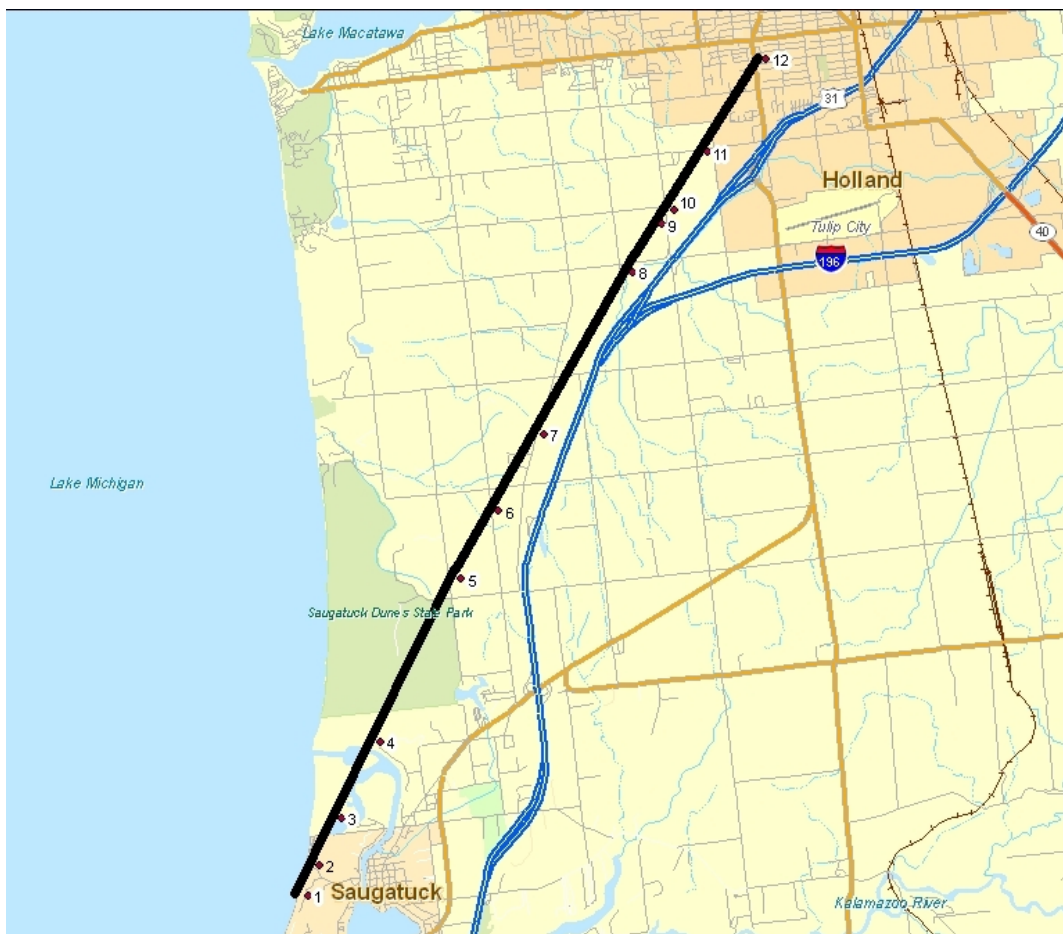
Figure 9: The path of the Saugatuck to Holland tornado, with locations of damaged or destroyed buildings numbered: 1. Damage to several wooden cabins and a concrete block building at a summer camp. 2. A wooden beach house destroyed. 3. The Saugatuck Lighthouse and three outbuildings destroyed. 4. A small cabin destroyed. 5. A two story frame home destroyed. 6. Roof damage to a frame home. 7. A frame home destroyed. 8. Barn unroofed. 9. and 10. Barn destroyed. 11. One story brick home destroyed. 12. Windows blown out of a two story concrete retail building.

it destroyed four homes and did significant damage to several other buildings (Fig. 9). The tornado damage path began at Camp Gray, a Presbyterian summer camp built on the sand dunes overlooking Lake Michigan, where several buildings sustained heavy damage. The path continued north-northeast to the popular summer resort area of Oval Beach, where the beach house was destroyed. The tornado then flattened the historic 97-year-old Saugatuck Lighthouse. All of these buildings were deserted at the time. The tornado crossed the Kalamazoo River and did minor damage at the David Bennett estate (point 4 in Fig. 9), where an eyewitness recalled seeing the debris cloud approaching, including a screen door floating high in the air. Five people suffered minor injuries as the tornado continued northeast and leveled two homes in rapid succession. Several farms received varying degrees of damage and another home was destroyed before the tornado damage path ended, just as it was about to move into a residential area on the southern outskirts of Holland, Michigan (Fig. 10). The funnel cloud was observed moving over the southeast part of Holland and dissipated near the town of Zeeland, where debris was seen

I added Fig. 9 showing points of damage for the Holland to Saugatuck tornado damage path in its entirety. The path was only nine miles long. The other tornado damage paths were all over 50 miles, so it would be impractical to make similarly detailed maps for them. I added a map (Fig. 4) of a section of the Bangor to Lowell tornado damage path. It is possible that there was a break in the tornado damage path here and that the light damage noted in this area was caused by downbursts. It is also possible that no structural damage was noted since this was a sparsely populated area and there were no buildings to be impacted directly by the tornado.

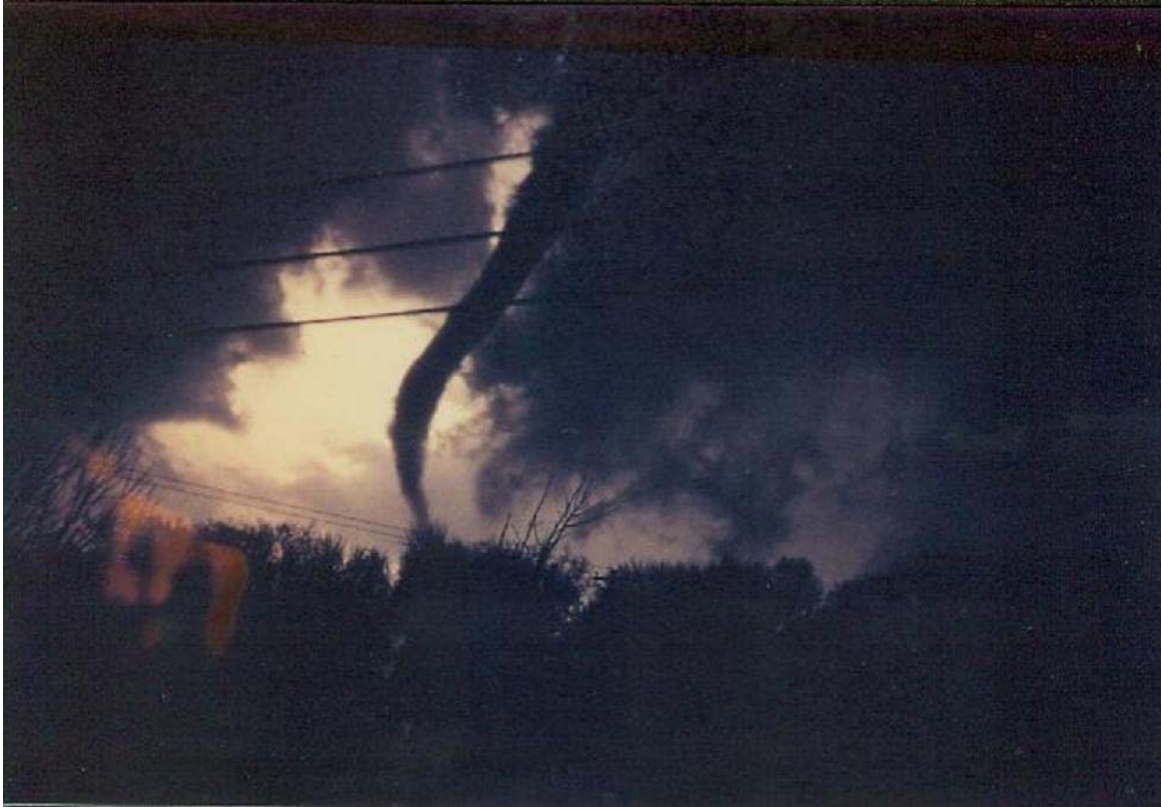
Figure 10: The Saugatuck to Holland tornado seen shortly before the damage path ended, as it was moving into a residential section of Holland, MI. Photo credit: Don Brink.

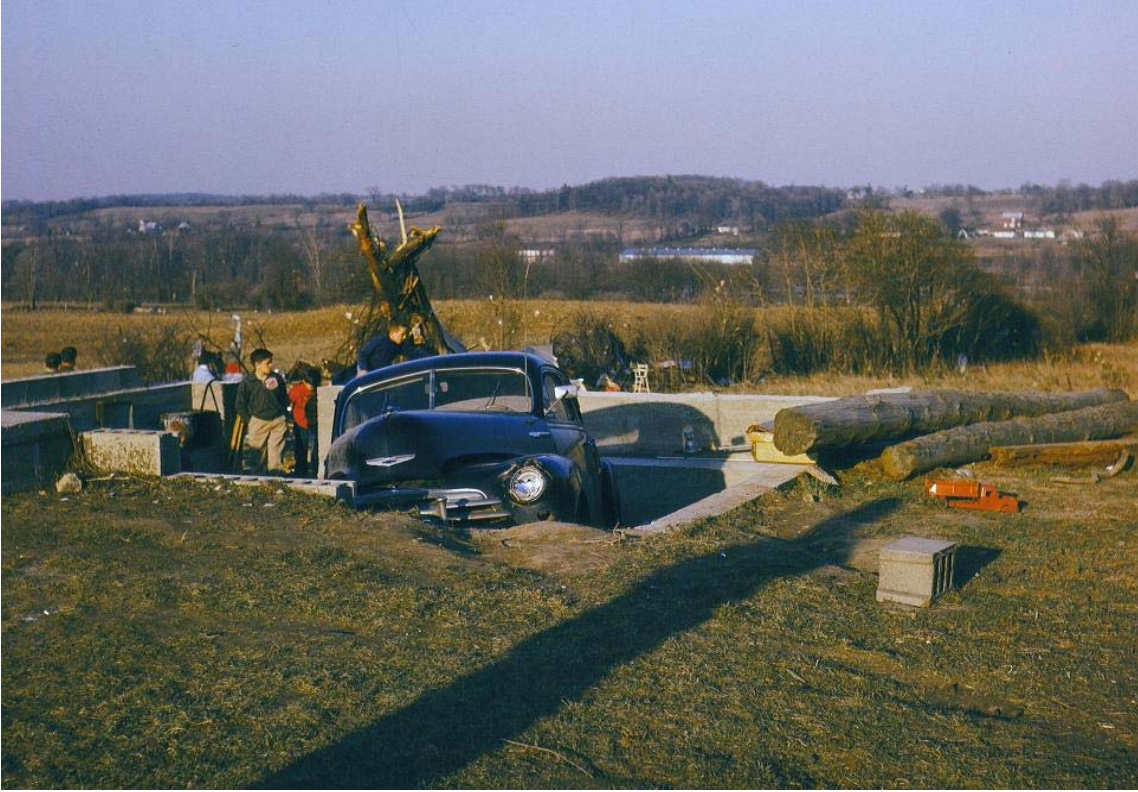
Figure 11: A car sits in the foundation of a home near Rockford, MI, after being hit by the Hudsonville to Lakeview tornado. No injuries resulted as the house was vacant at the time. At least two other homes in this area were destroyed and several others had extensive damage. There is no indication how or if this home was secured to its foundation, therefore winds in the F4 range cannot be inferred. Photo credit: Jack Erickson.

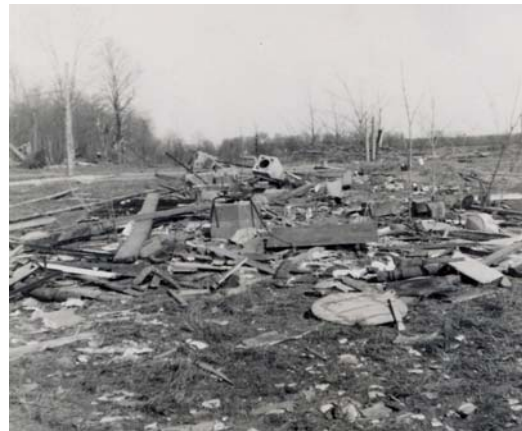
Figure 12: The remains of the Hugh Parks residence in Benzie County, MI where one fatality occurred. Photo credit: Al Chapman.

destruction of at least two homes in Benzie County. The remains of one of them can be seen in Fig. 12, where the lone fatality from this tornado occurred. The NCDC and Tornado Project databases each list two fatalities for this tornado, with the latter describing a couple being killed when the second floor of their house was torn off. However, an eyewitness stated that she and her infant son were visiting the couple when the tornado struck and that they were all on the first floor. The house was demolished and her aunt was killed while her son and uncle were seriously injured. Local newspaper articles corroborate this. Several injuries occurred in the small towns of Lake Ann and Cedar Run in northeast Benzie County, where at least two homes were destroyed completely. The tornado did relatively minor damage to a few farms in Leelanau County before it moved offshore and dissipated over Grand Traverse Bay.

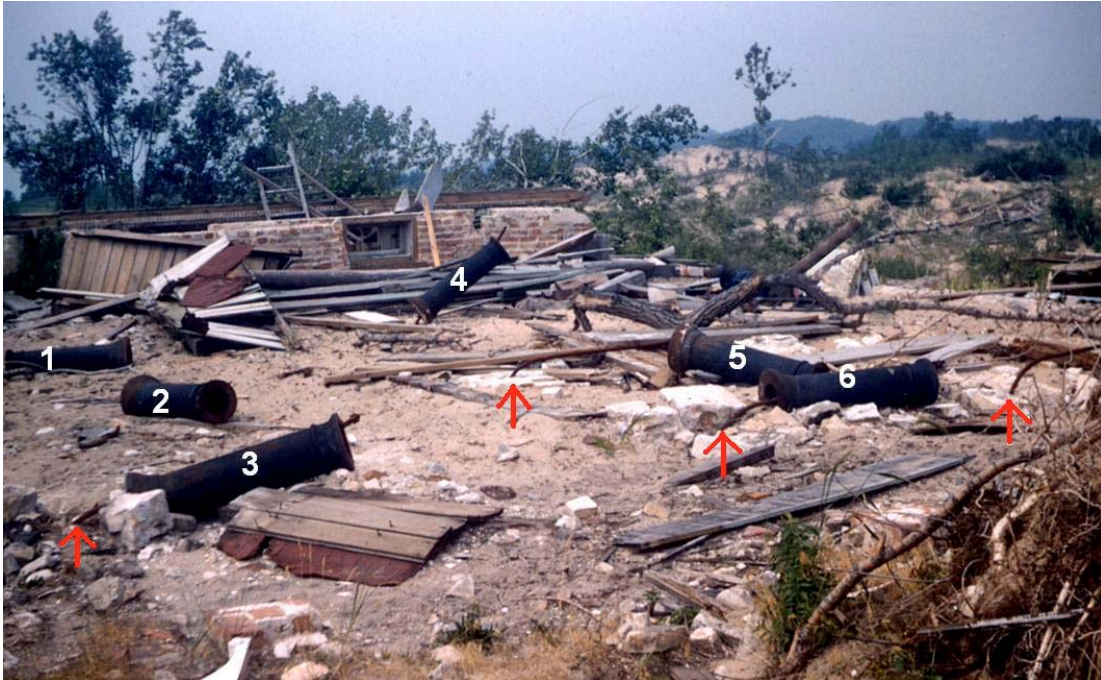
Figure 13: The remains of the Saugatuck Lighthouse. (a) The foundation. Six of the twelve cast iron pylons can be seen, labeled with numbers. Pylons labeled 4 and 6 still are attached to the foundation by their anchor rods. Other locations where the anchor rods still are attached to the brick and mortar foundation are indicated with arrows. (b) The main mass of debris of the destroyed lighthouse. Note the iron anchor rods still attached to the wooden beam. Photo credits: Norm Deam.

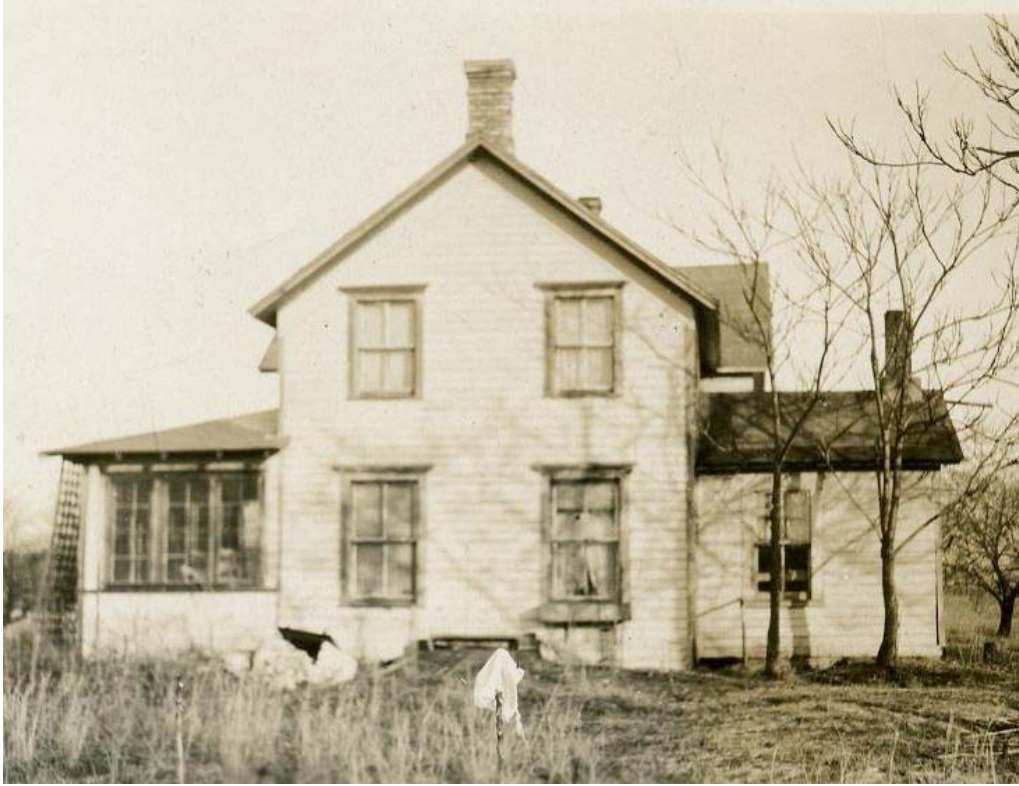
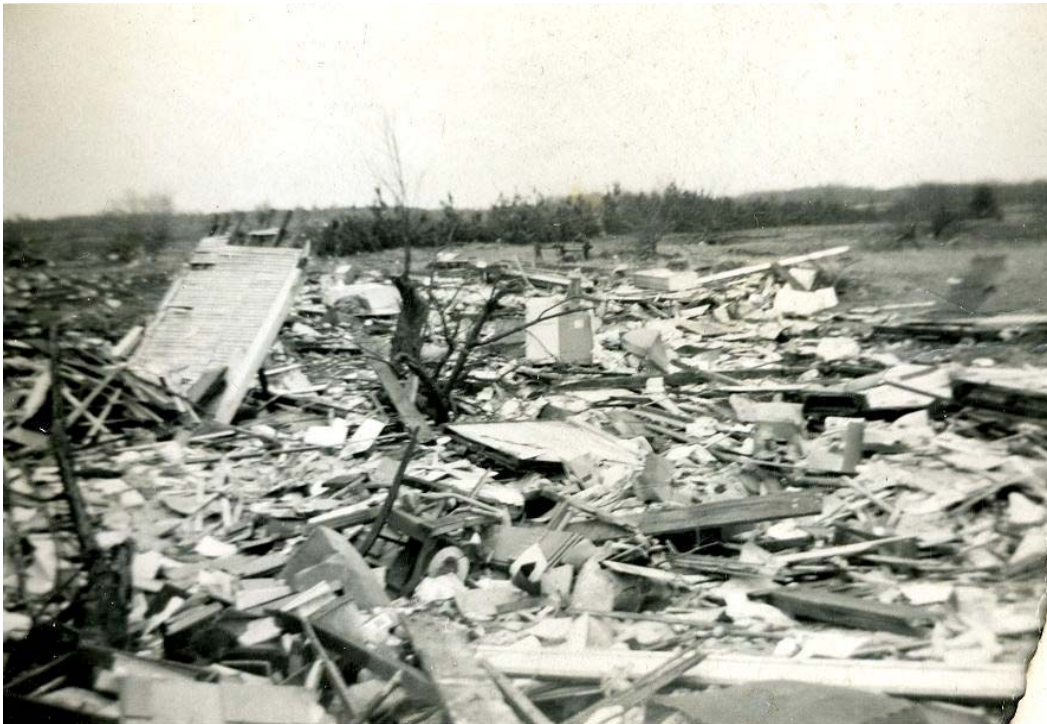
Figure 14: The James Boyce house in Allegan County, MI. (a) The house circa 1935. (b) The remains of the house after the tornado. Photos courtesy of James Boyce.

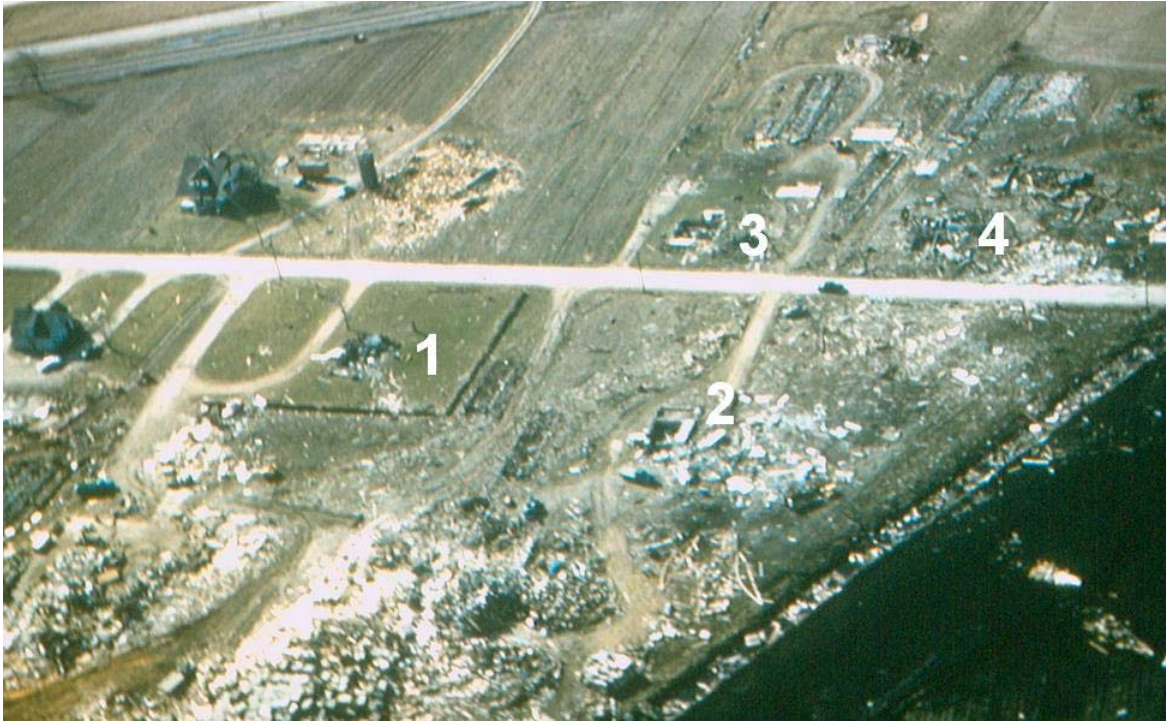
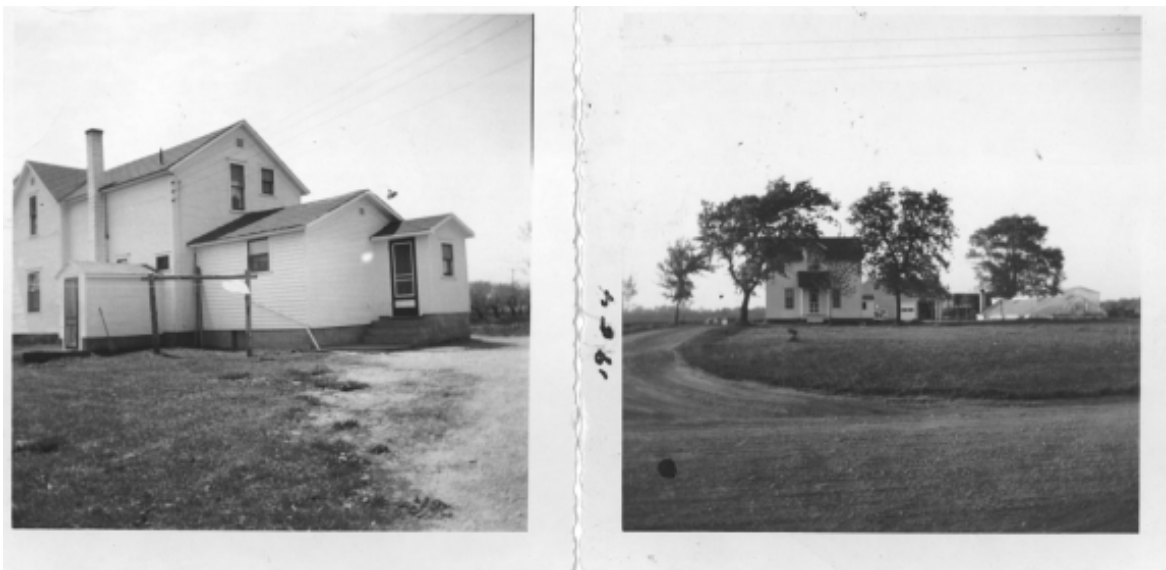
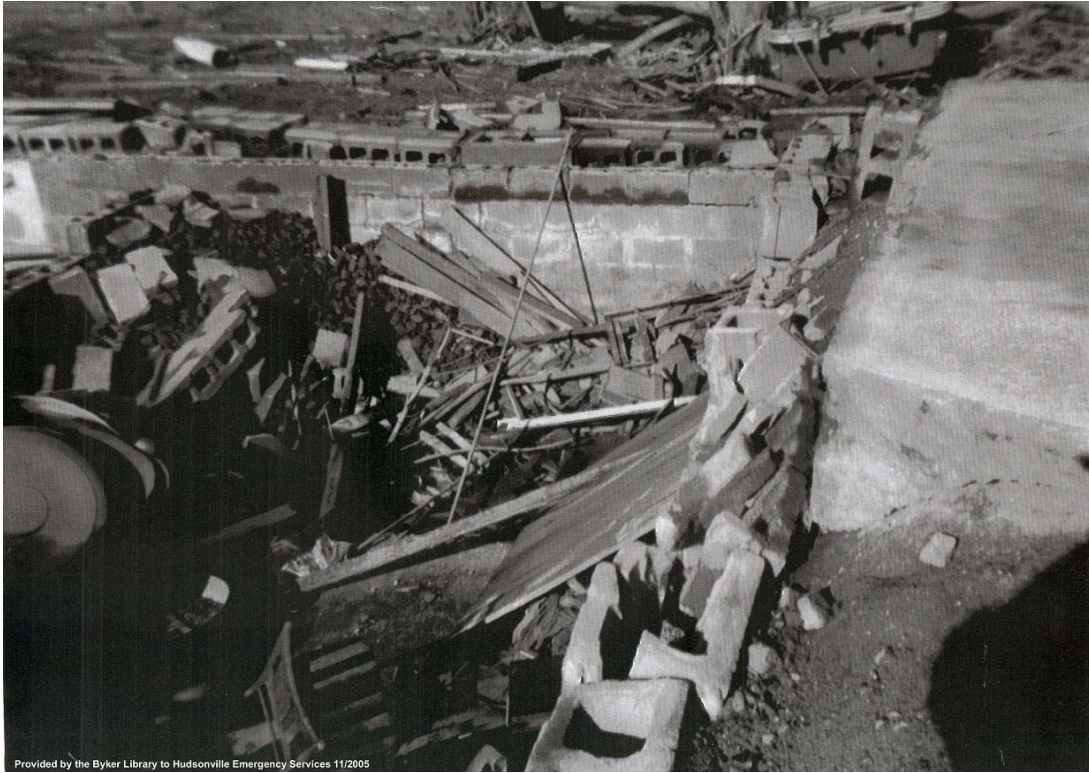
Figure 15: (a) Aerial photo of damage on New Holland Street in Hudsonville, MI. Four empty foundations mark the locations of homes that were swept away. The foundation of the Willard Brower home is labeled 2. Photo credit: Pete Ludema. (b) The Willard Brower home in 1954. Photo courtesy of Maxine Baker. (c) The foundation of the Willard Brower home. Photo courtesy of the Gary Byker Library.

The vast majority of the available photographic evidence was for the Hudsonville to Lakeview tornado, listed as an F5 (F4) in the NCDC (Tornado Project) data. Photos taken from an airplane a few days after the tornado show at least three homes completely destroyed and swept from their foundations on New Holland Street in Hudsonville, where the first fatality occurred (Fig. 15a). Fig. 15b shows one of the homes two years before, and Fig. 15c shows part of the foundation of the home after the tornado. There is no evidence that the home was secured to the foundation. Similar damage

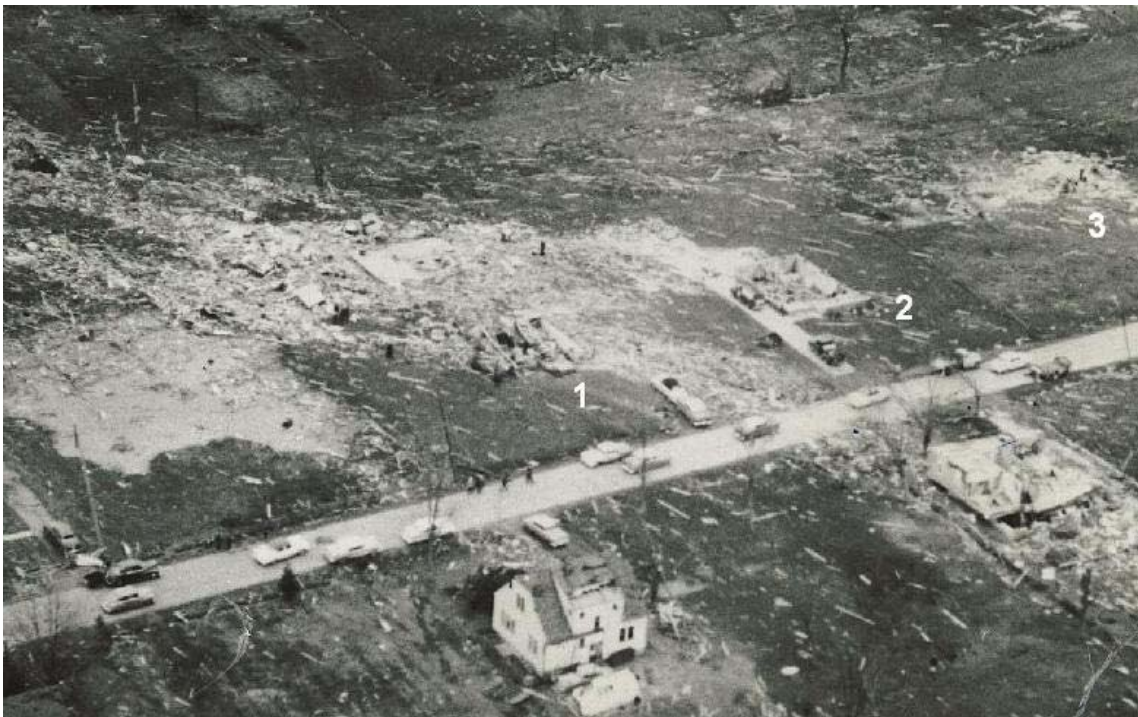
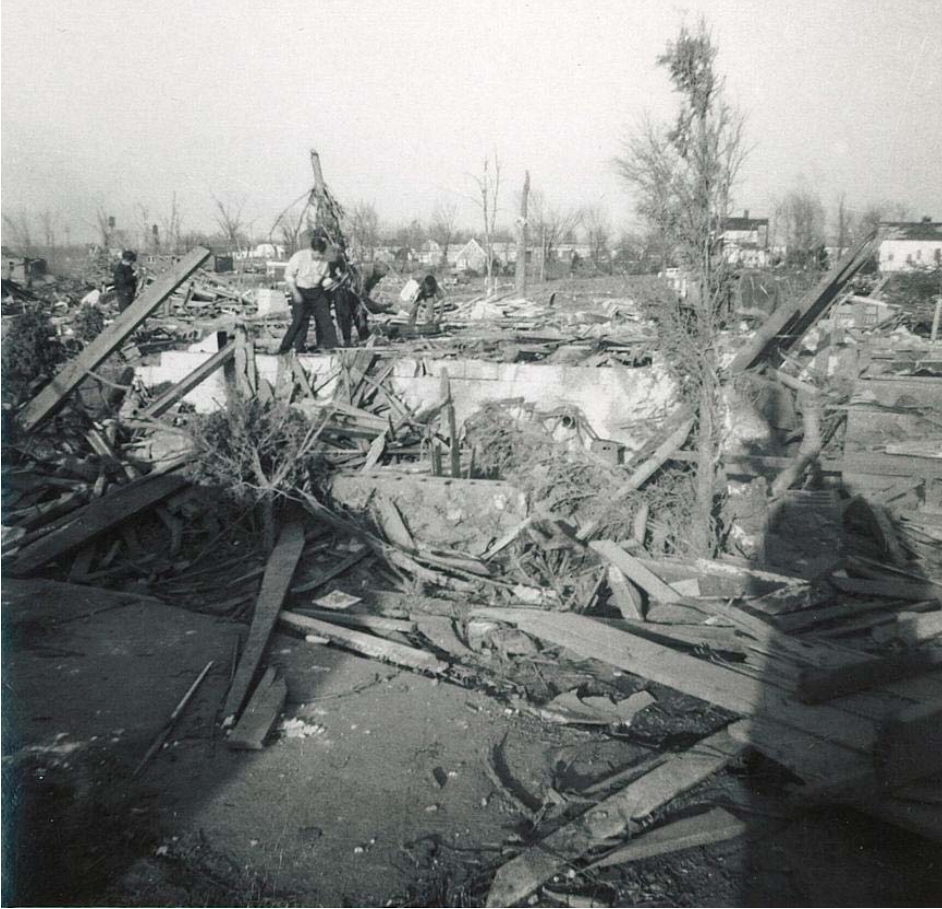
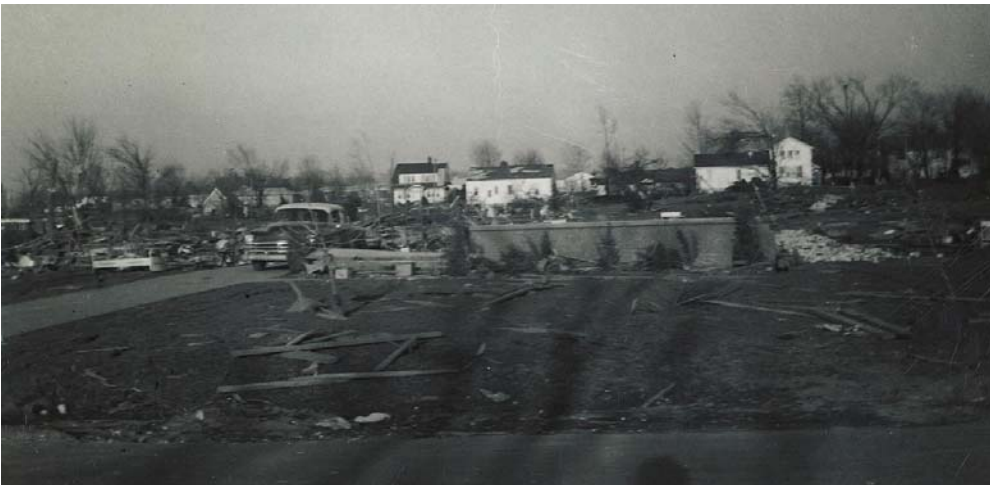
Figure 16: Damage in Walker, Michigan. (a) Aerial photo, with possible F5 damage at the homes labeled 1 and 2, and F4 damage at home 3. Note the debris streaks from the houses extending to the left (northeast). Photo courtesy of Richard Tuttle. (b) The remains of the home labeled “1” in Fig 16 a. This was a two story wood frame home. Although the home foundation does not appear to be “swept clean,” it is believed that most of the debris seen here originated elsewhere. The cinder blocks of the foundation may indicate that the home was not securely attached to the foundation. Photo courtesy of Richard Tuttle. (c) The home labeled “2” in Fig 16b. Other than being described as a duplex, little is known of the structural integrity. Photo courtesy of Richard Tuttle.

to homes and buildings occurred at several points along the path through Hudsonville and into the northwest suburbs of Grand Rapids. Fig. 16a is an aerial photo of tornado damage in a suburb northwest of Grand Rapids. Apparent damage was rated F5 for two homes and F4 for two others.

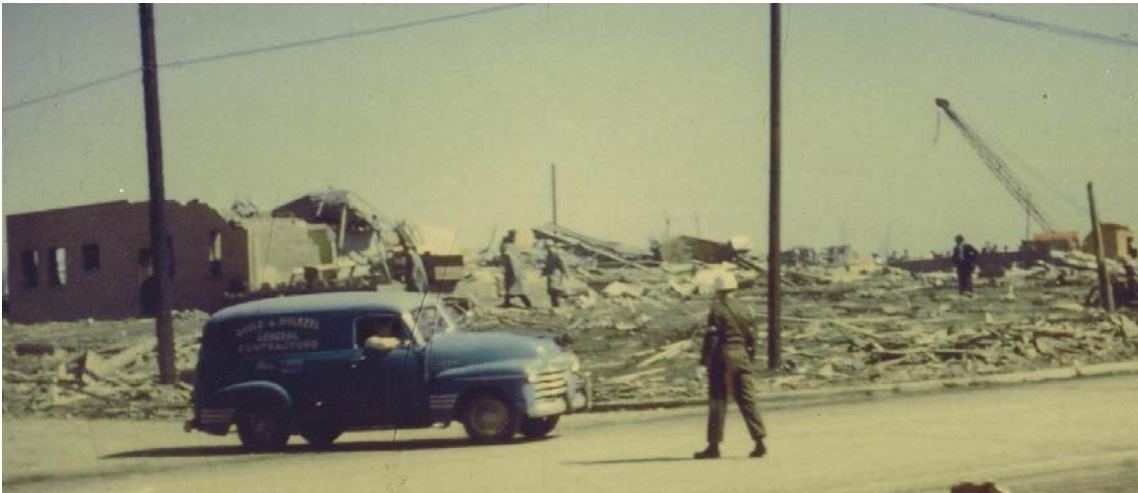
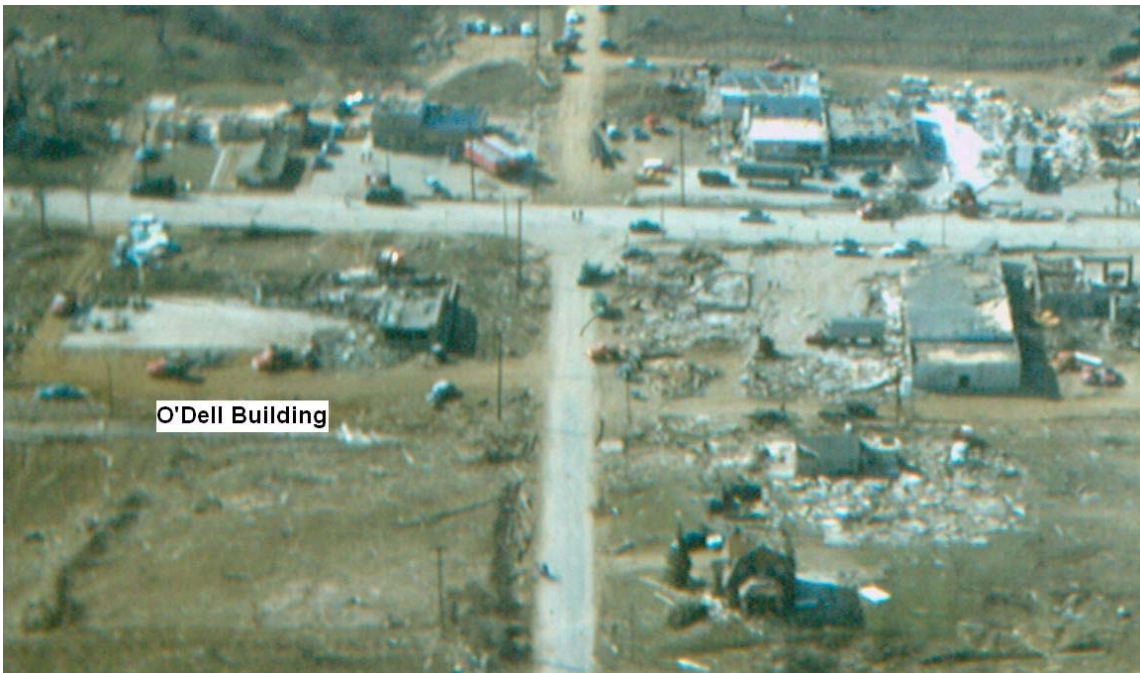
Figure 17: The remains of the O'Dell Manufacturing Company building in Standale. (a) The building extended to near where the crane is. Perspective is looking northeast. Photo credit: Lou Nichols. (b) The O'Dell building seen from the air after much of the debris, including steel beams, had been removed. Perspective is looking south. Photo credit: Pete Ludema.

Damage was widespread in the Standale area, as several businesses and homes were leveled and almost completely swept away, including a new manufacturing plant. The remains of this building are seen in Fig. 17a and 17b, with only one corner left standing. An EF-4 rating would seem appropriate for this damage, using the “large isolated retail building” damage indicator.

With some exterior walls still standing, this looks like F3 damage, depending on the width and location of the tornado track relative to this building [the O'Dell manufacturing building in Standale]. Was it hit dead on, or are the exterior walls still standing on the margins of the track? Or is it possible to tell?

I added Fig. 17, better showing the extent of damage to this building. As far as I can tell the building took a direct hit from the tornado. A grocery store of across the street (to the right in Fig. 17b) was destroyed completely.

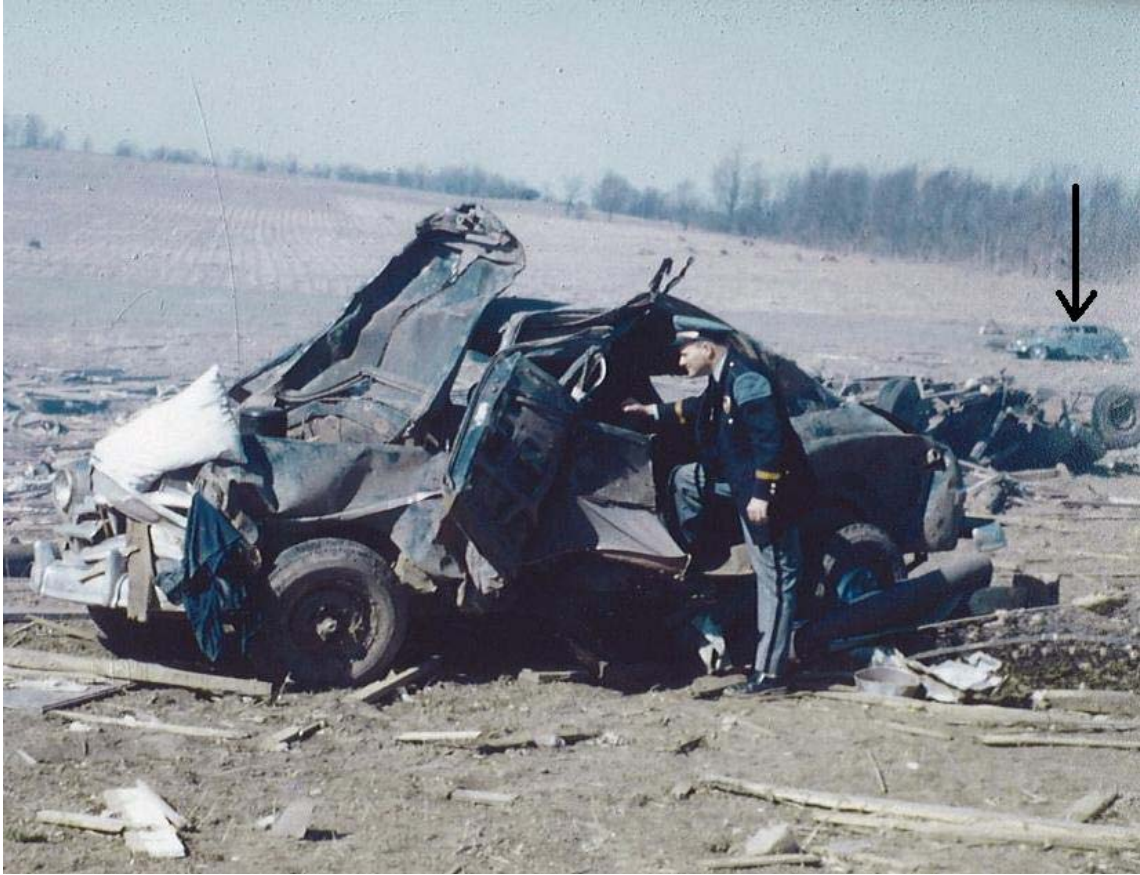
Figure 18: This car came to rest more than 100 m from the road from which it was swept. Another car (marked with arrow) in this photo may have been carried an even greater distance. Photo courtesy of Al Vanderbeek.

The tornado carried several cars for long distances. The most reliable reports of that nature come from Hudsonville, where cars were photographed after having been carried or rolled far from their points of origin. One auto, with four people inside, was said by eyewitnesses to have been lifted about 30 ft (9 m) in the air before it came to rest in an open field. Two people in the car were killed. One of the survivors was interviewed, and said the car was carried more than 100 m (109 yards), indicating F5 damage (Fujita, 1971). At least two other cars were carried by the tornado for even greater distances (Fig. 18). The Portage Point to Grand Traverse Bay tornado demolished at least four homes for which photographs of the remains exist. The damage appears consistent with the official F4 rating and would indicate EF-4 damage if the homes were well-constructed.

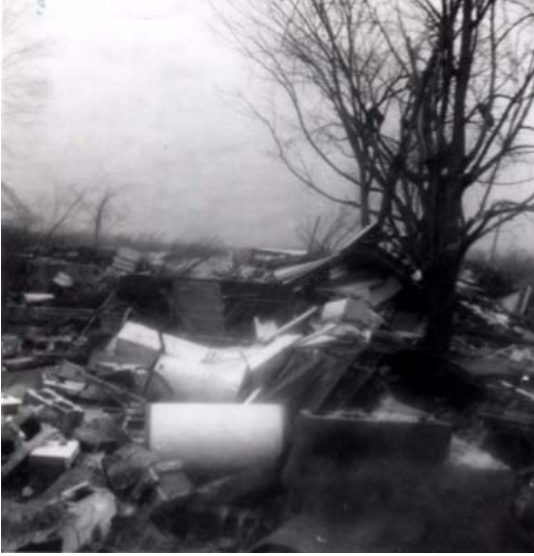
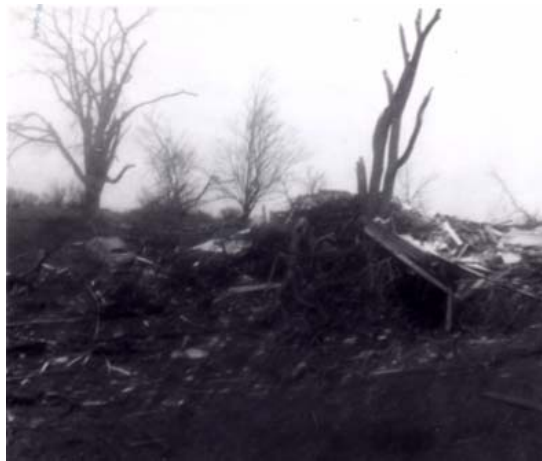
Figure 19: The remains of the Ray Imig home near Bloomingdale, Michigan. Although the house was leveled, several trees surrounding the house had limbs removed, but remained standing. Photo credit: Harold Burlleson.

Letters, a truck title, and other papers from this same home were carried as far as Saginaw, about 80 mi (129 km) away. Clothing from a destroyed department store in Standale was found almost 50 mi (80 km) to the northeast. Several farms in northern Kent County were littered with debris carried from Hudsonville and Standale, to the extent that a farmer described the trees around his house as being “decorated like it was Christmas” with clothing and other debris. The fields had to be “passed over” to collect the debris before they could be plowed that spring.

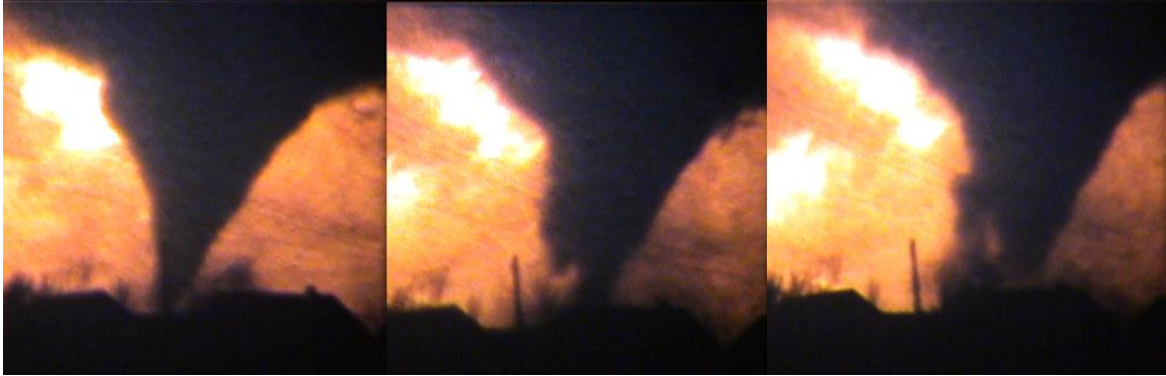
Figure 20: These three still frames from an 8 mm home movie of the F5 Hudsonville to Lakeview tornado show the formation of a suction vortex on the left (west) side of the main funnel. The tornado was moving through the northwest suburbs of Grand Rapids at the time. Photo credit: Eugene Dohm.

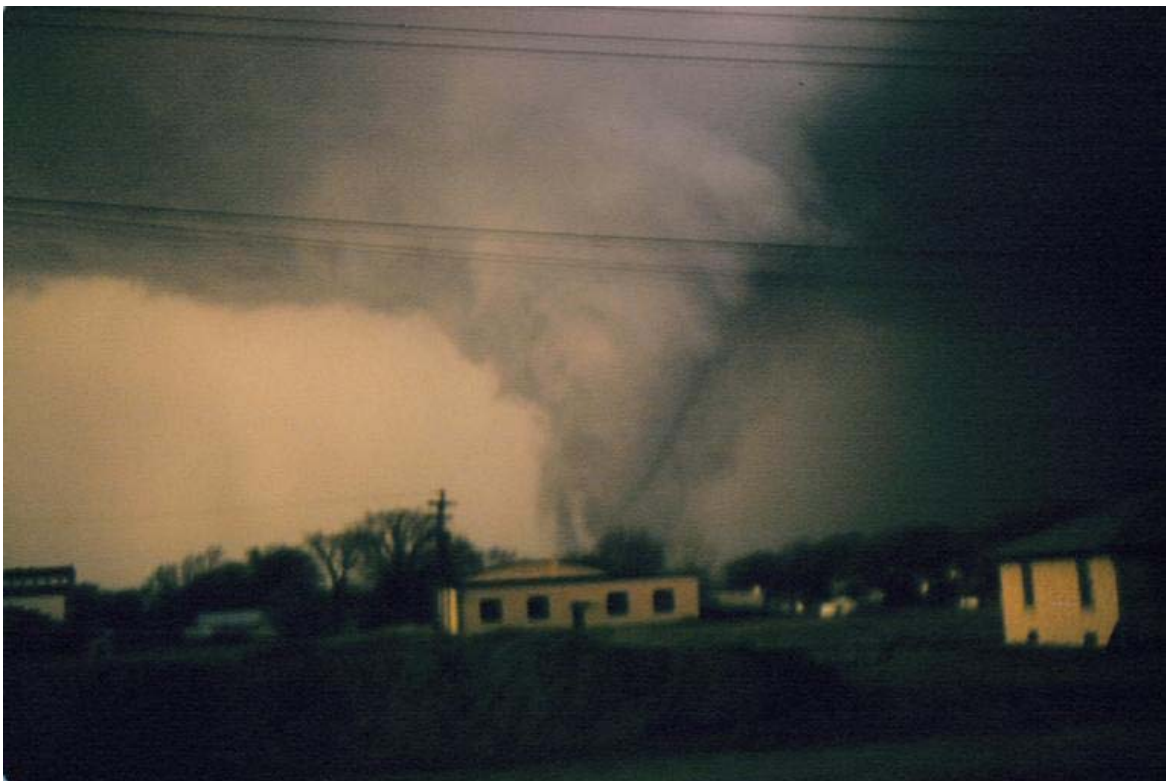
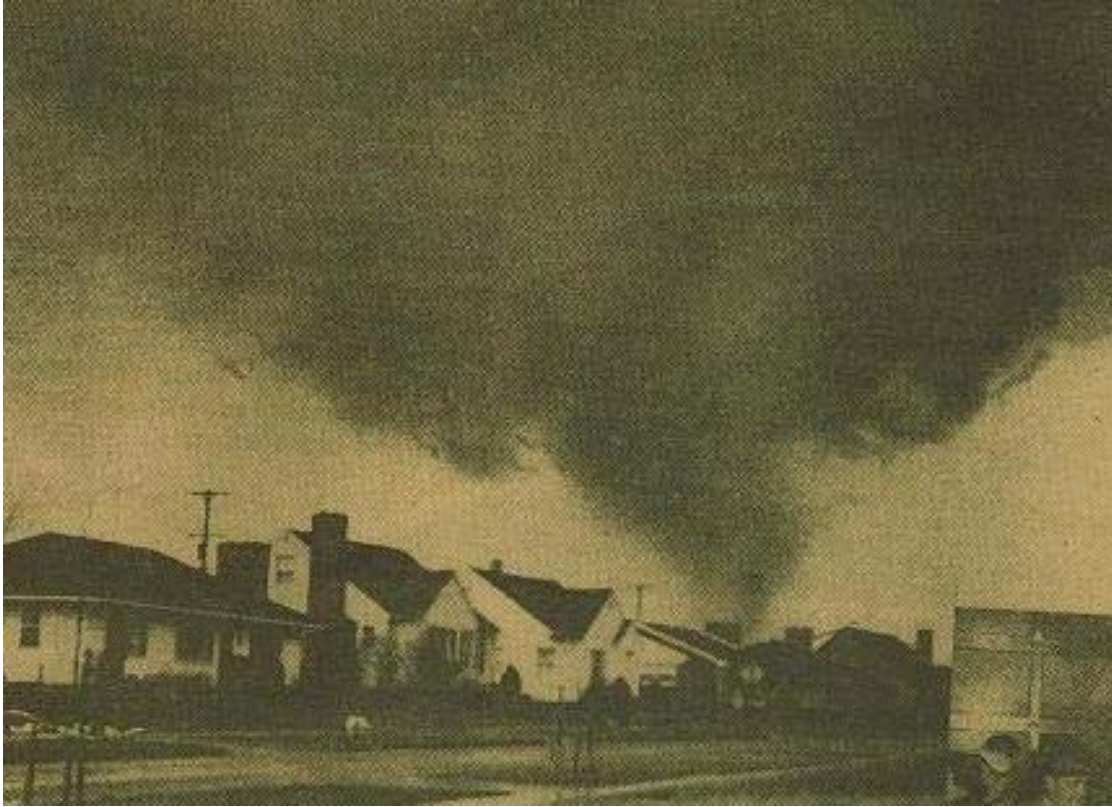
Figure 21: The Hudsonville to Lakeview tornado: (a) Moving through the northern outskirts of Hudsonville on 3 April 1956. Photo credit: Myrtle Coats. (b) See next page. Moving through Comstock Park, MI, and exhibiting suction vortices. Photo credit: *Grand Rapids Herald*.
